**ENVIRONMENTAL AND MECHANICAL  
SYSTEM ASSESSMENTS  
25 SIGOURNEY STREET, HARTFORD, CT**

**ENVIRONMENTAL AND MECHANICAL  
SYSTEM ASSESSMENTS**

**25 SIGOURNEY STREET, HARTFORD, CT**

**EH&E Report #11767**  
**August 13, 2004**

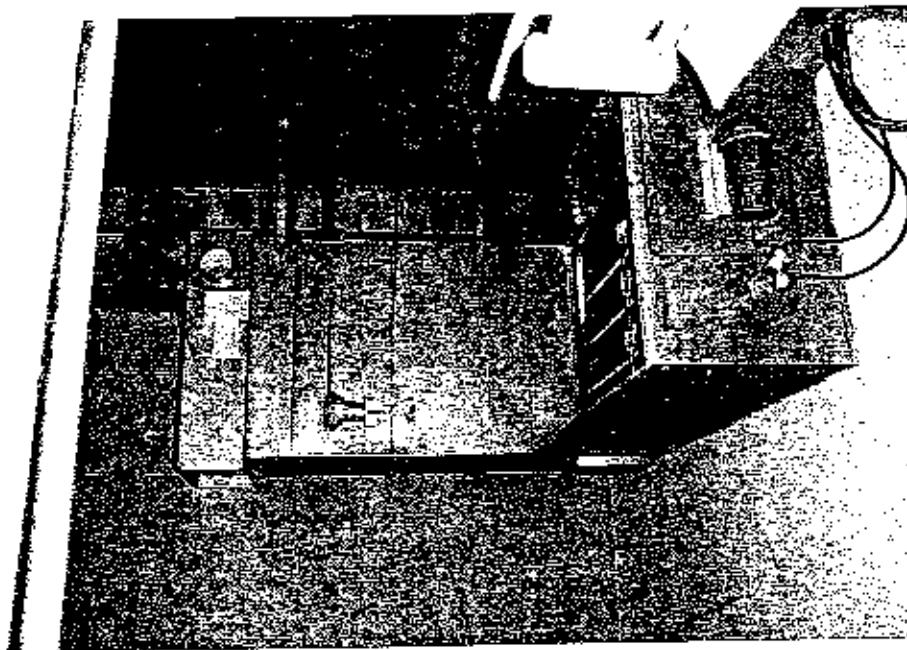
**Figure 4.2** Photo of Outdoor Air Flow Measurement and Control Station Installed in a Typical Mechanical Room (DCP\_0115.JPG)

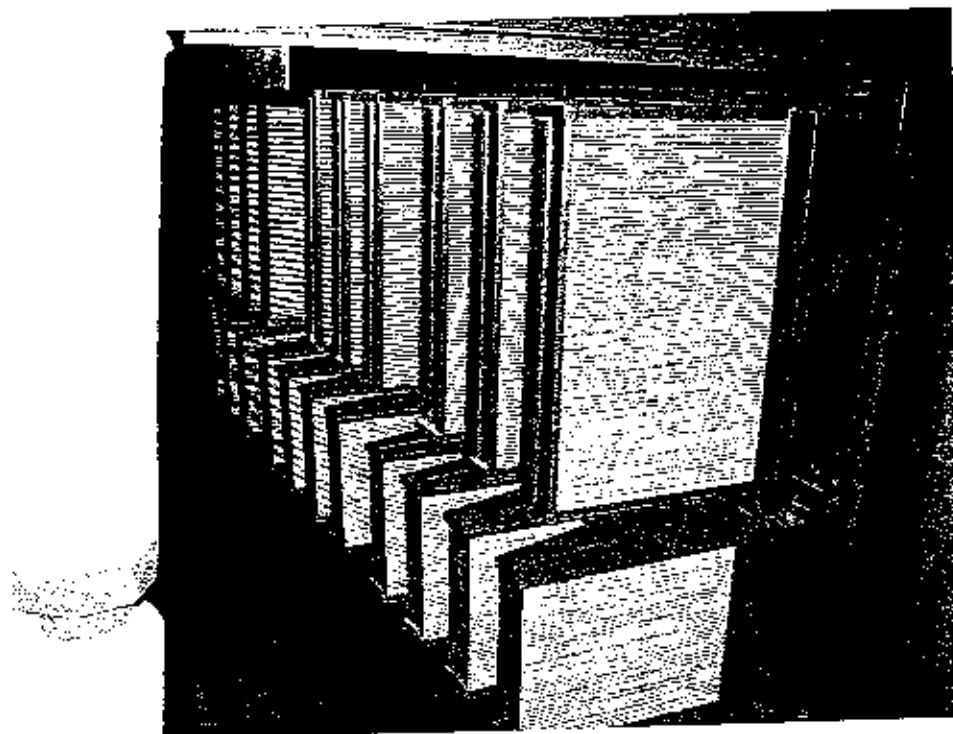
**Figure 4.3** Photo of Typical Filter Installation in an Air Handling Unit (0109-0939\_IMG.JPG)

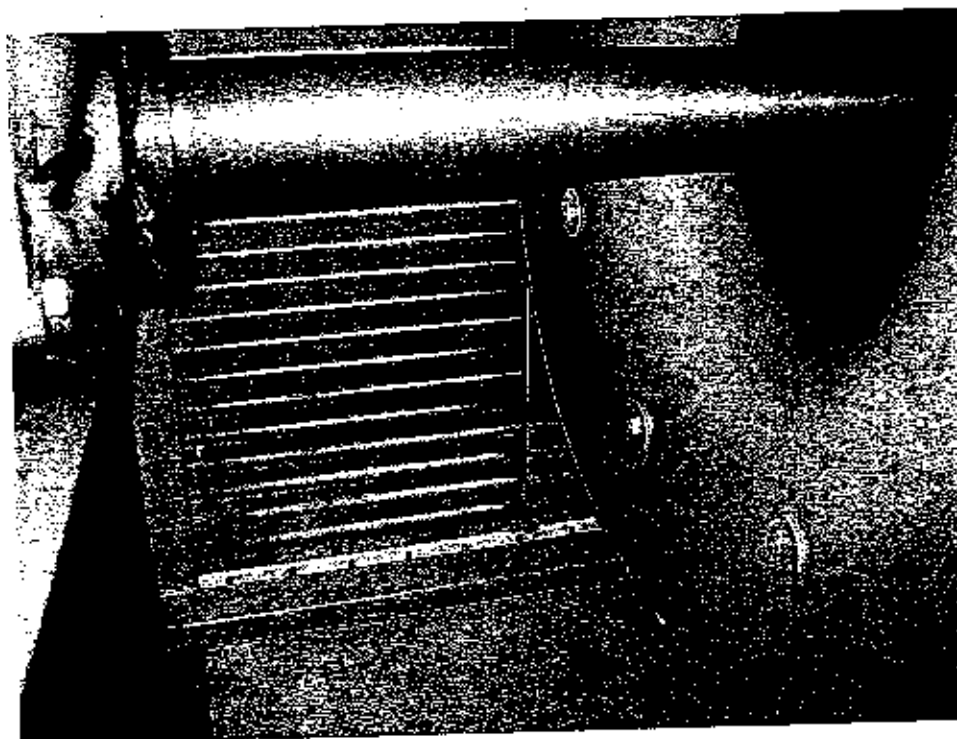
The air handling units were inspected inside and observed to have clean coils, clean linings, etc. According to building management, the systems had been recently cleaned. The units had been fitted with filters that fit in their racks in a manner that minimized the amount of air bypass that normally occurs in normal HVAC equipment.

**Figure 4.4** Photo Inside a Typical Air Handling Unit, Showing the Cleanliness of the Coils, Fan, and Bottom of the Drain Pan (109-0936\_IMG.JPG)

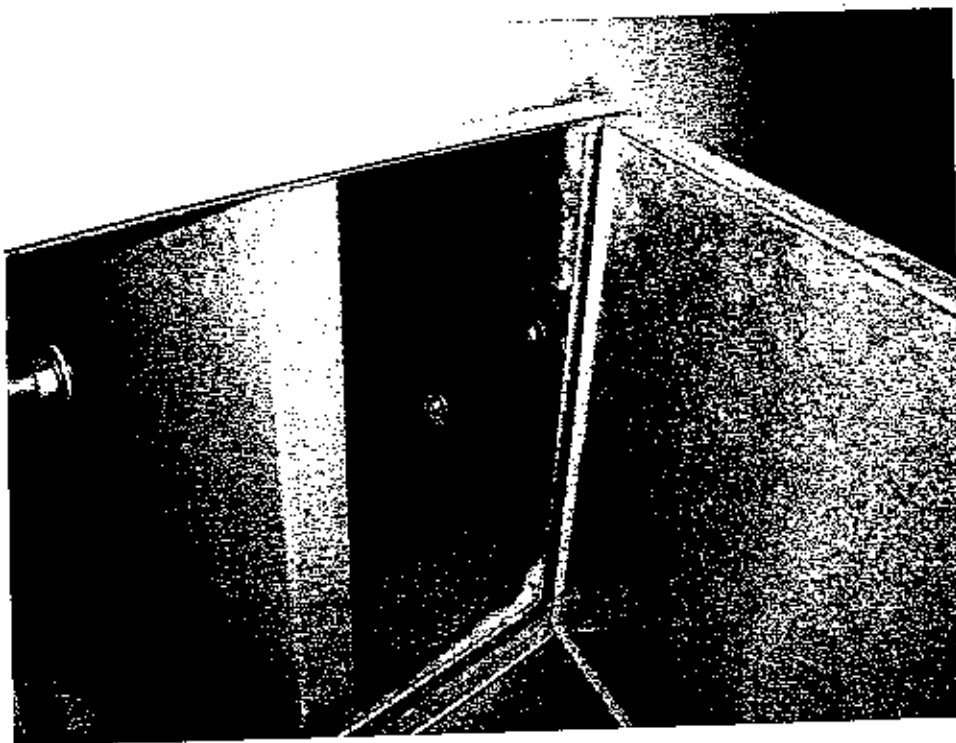
**Figure 4.5** Photo of Cleaning and Inspection Access Panel in Typical Air Handling Unit (109-0948\_IMG.JPG)
